1. AGENCY USE ONLY (Leave Blank)	2. REPORT DATE March 1996	3. REPORT TYPE AND DATES COVERED Final Technical Report 010992 - 290296		
4. TITLE AND SUBTITLE Damage and Failure Behavior of SiC SCS-6/Timetal 21S Metal Matrix Composite		5. FUNDING NUMBERS FQ8671-9201544 2302/BS <i>92-C-0063</i>

6. AUTHOR(S) D. A. Shockey, S. W. Kirkpatrick, C. G. Schmidt, and T. Kobayashi				
7. PERFORMING ORGANIZATION NAME(S) AND ADDRESS(ES) SRI International 333 Ravenswood Avenue Menlo Park, CA 94025-3493		8. PERFORMING ORGANIZATION AFOSR-TR-96 <i>0250</i>

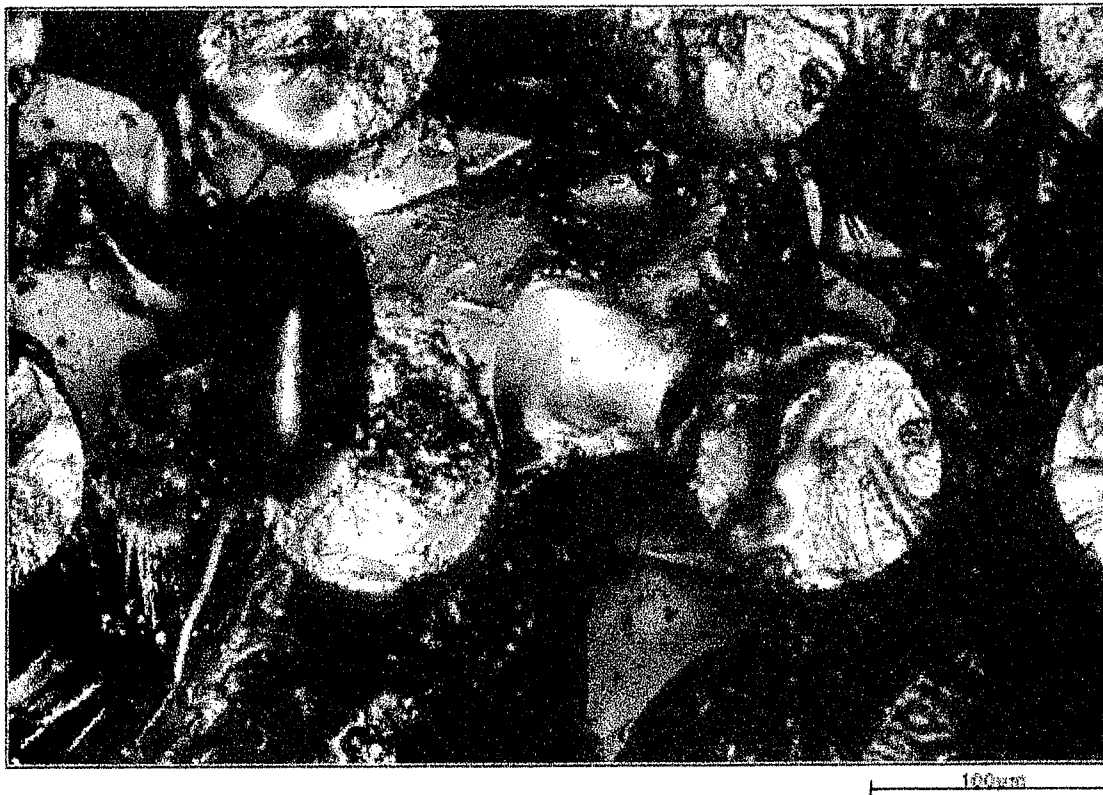
Figure A.2. Contrast and elevation images of Surface A.

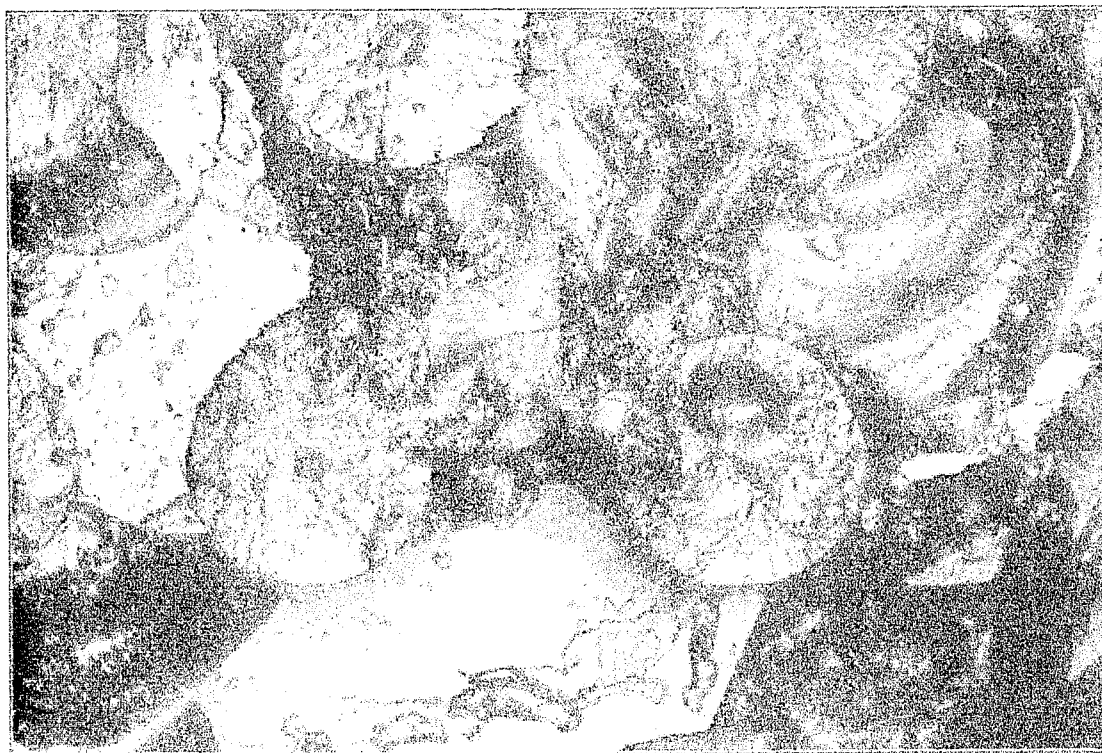
Figure A.3. Contrast and topography images of Surface B.

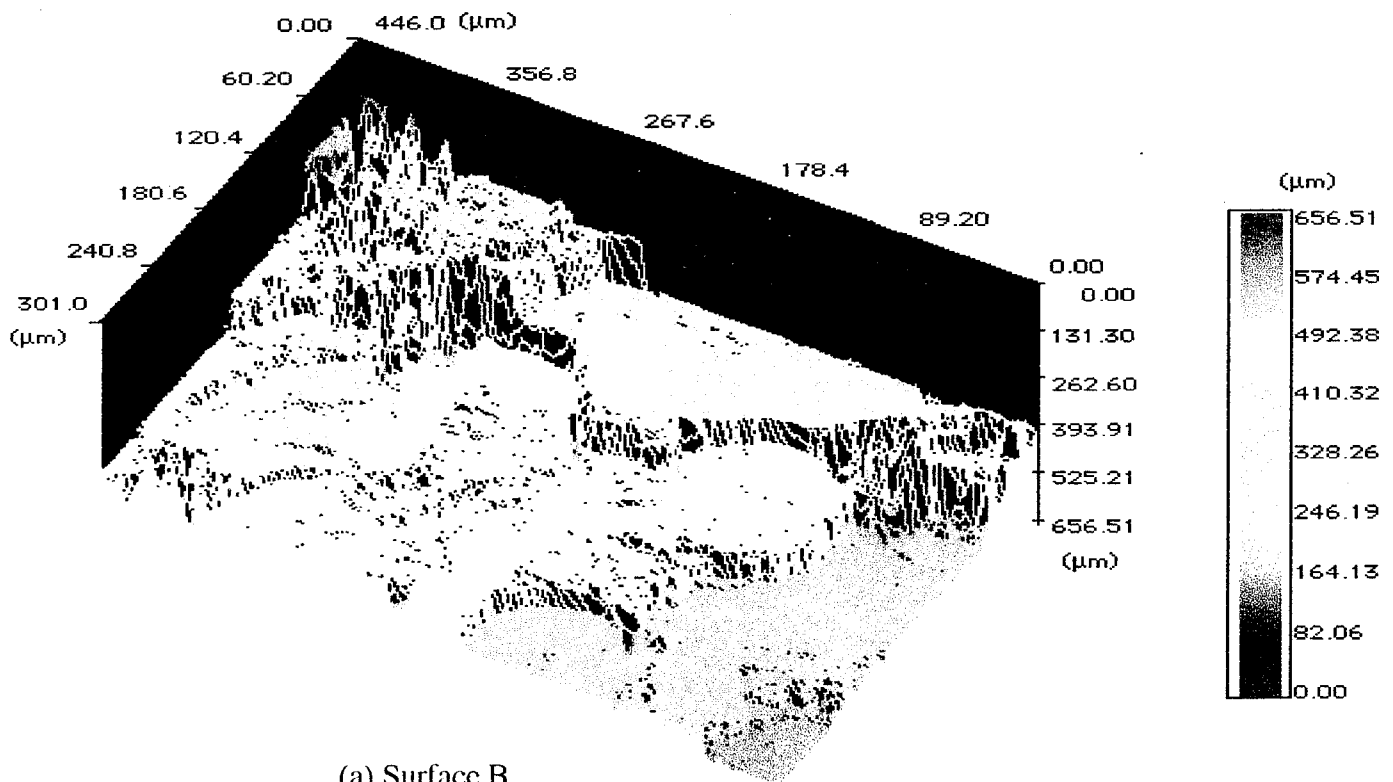
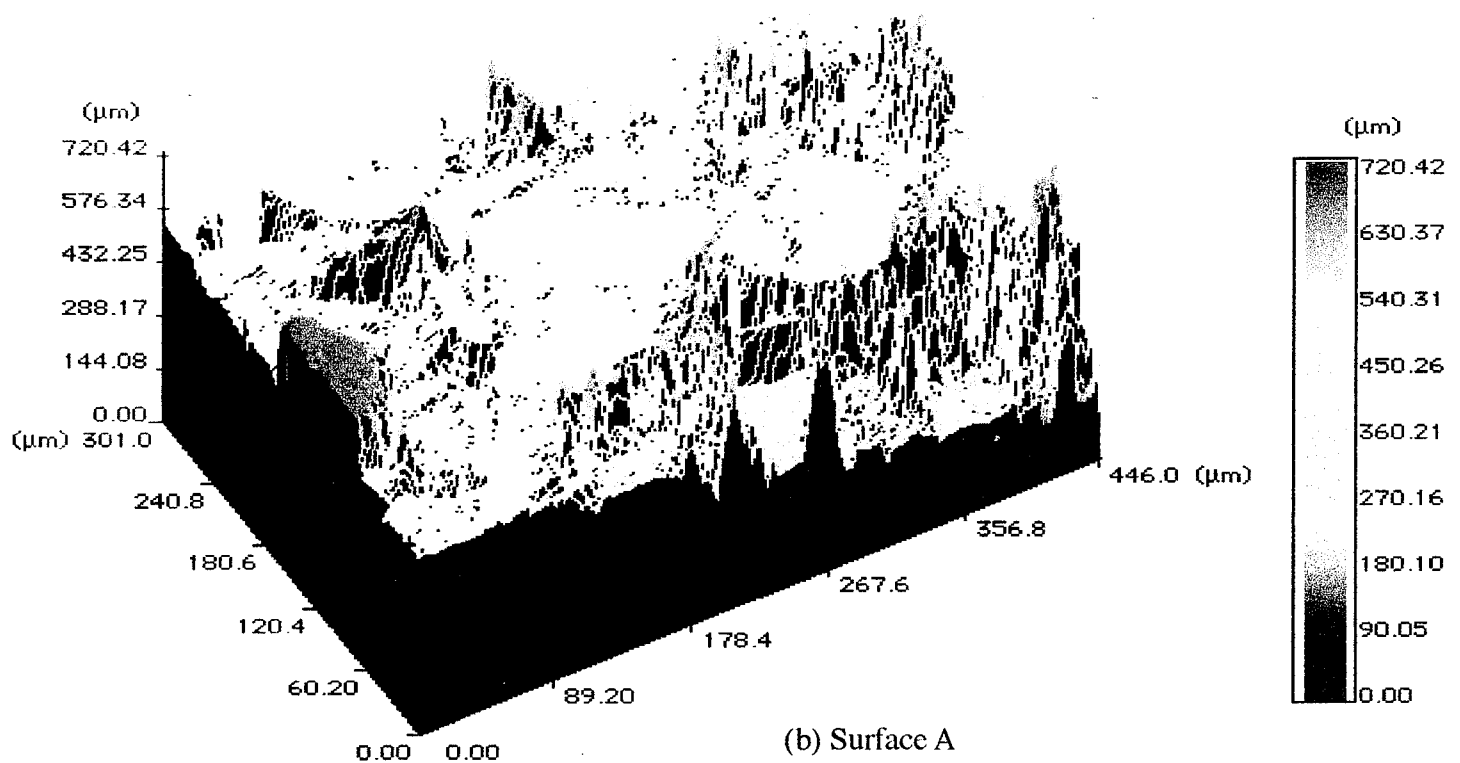
Figure A.4. Perspective views of conjugate fracture surfaces.

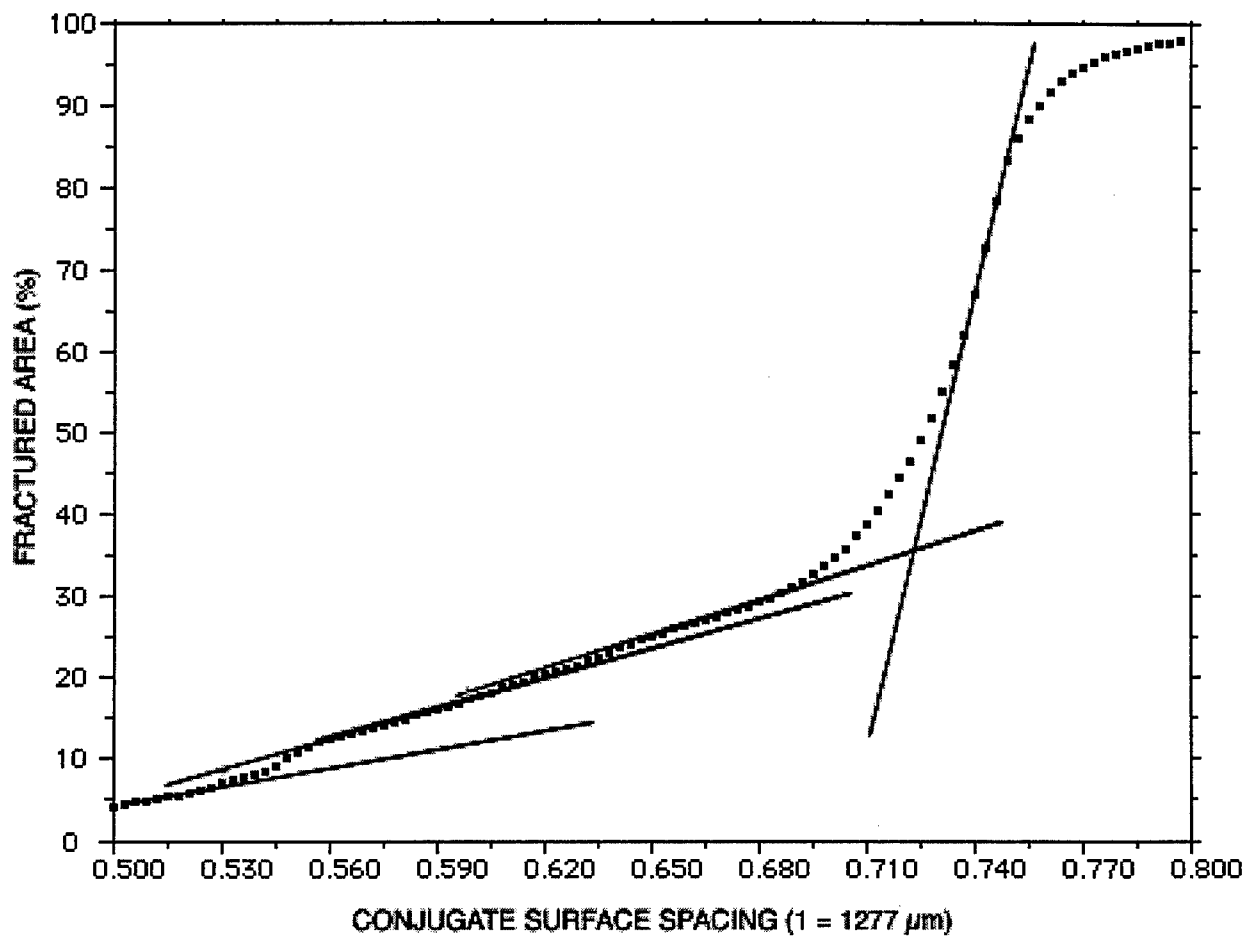
Figure A.6. Fractured area increase rate as a function of conjugate surface spacing.

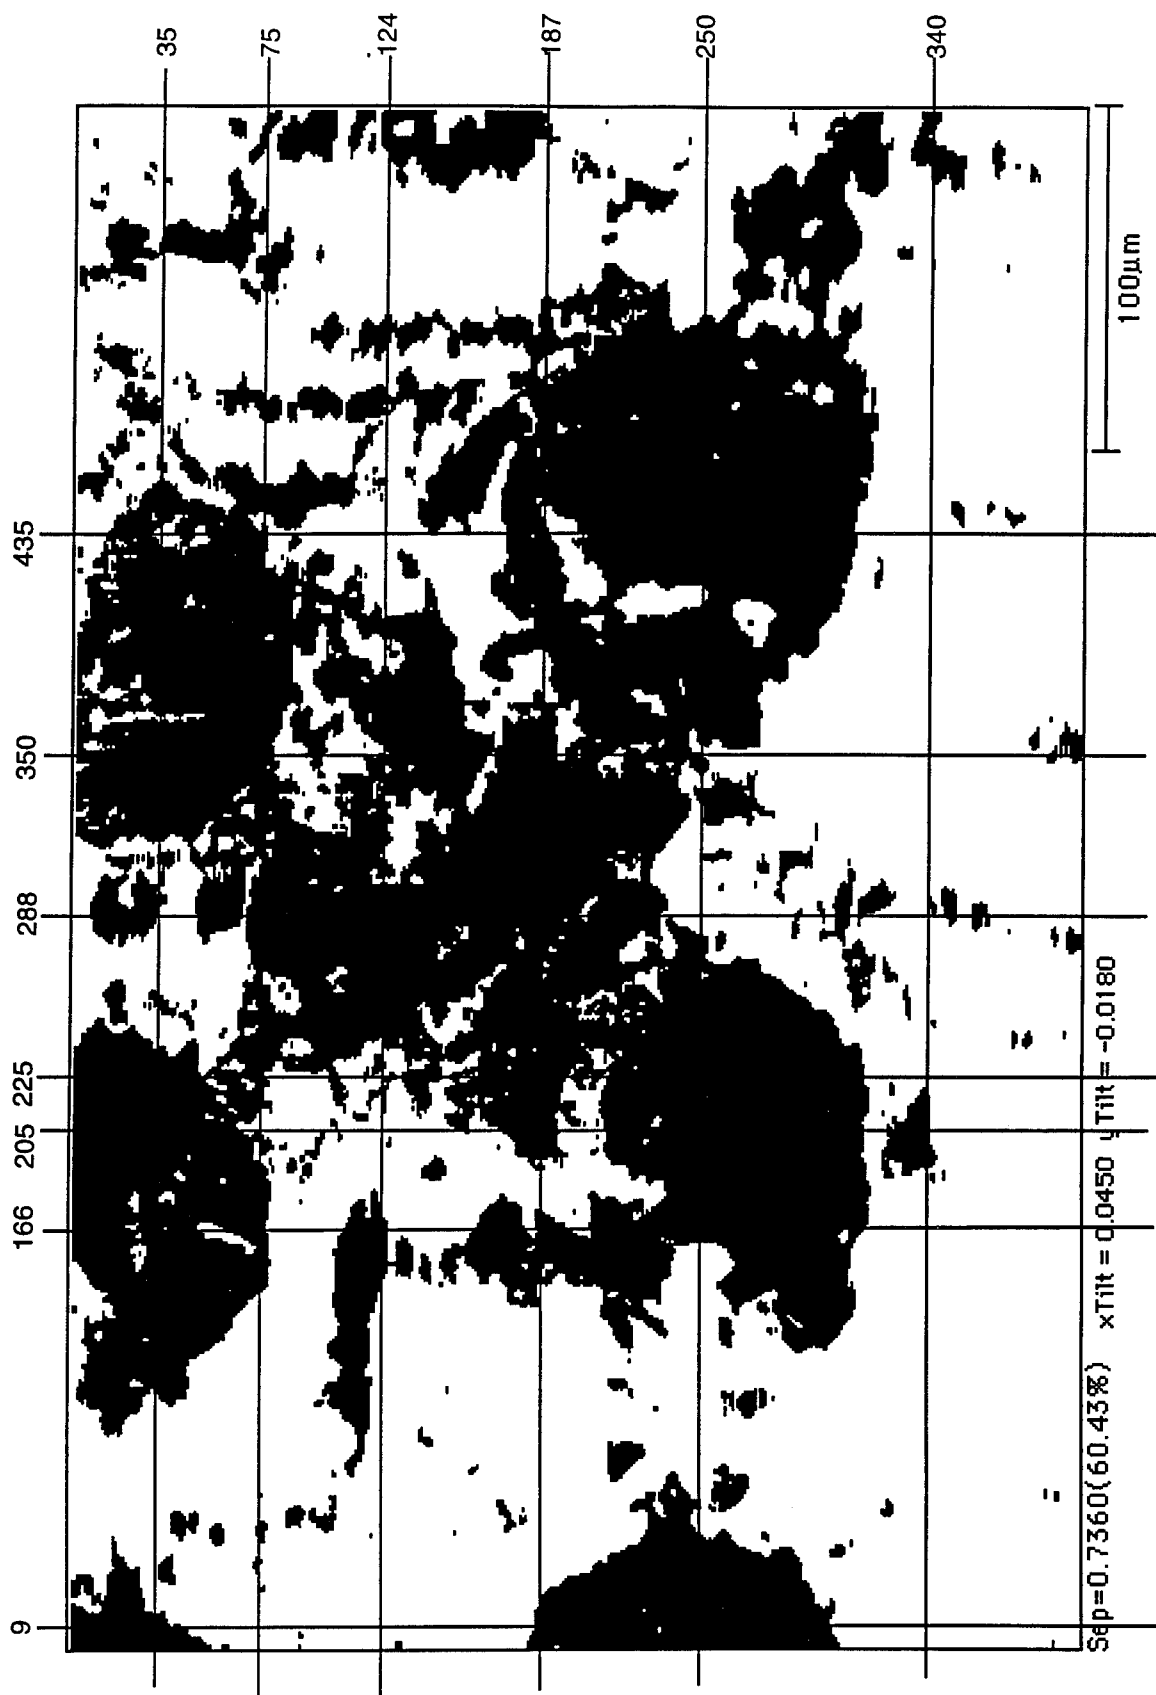
Figure A.7. Fractured area projection plot showing the locations at which cross-sectional plots were made.

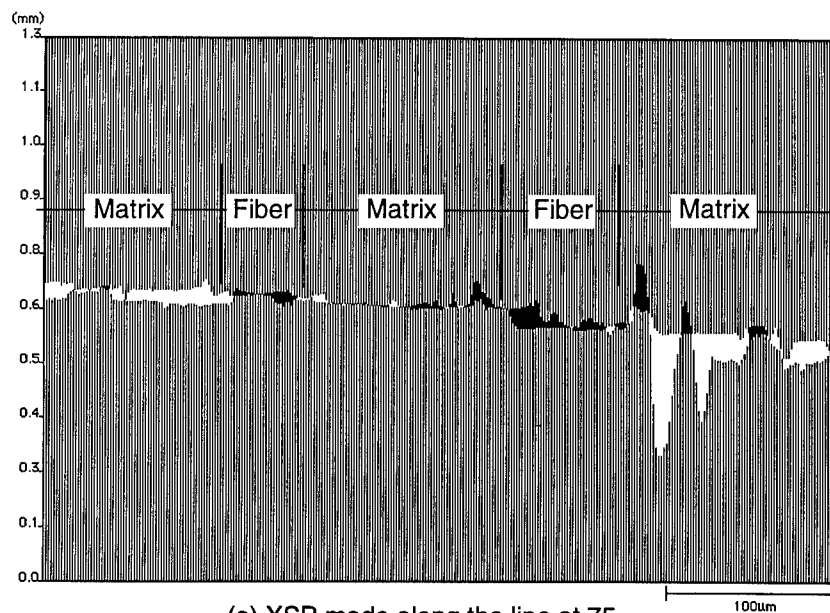
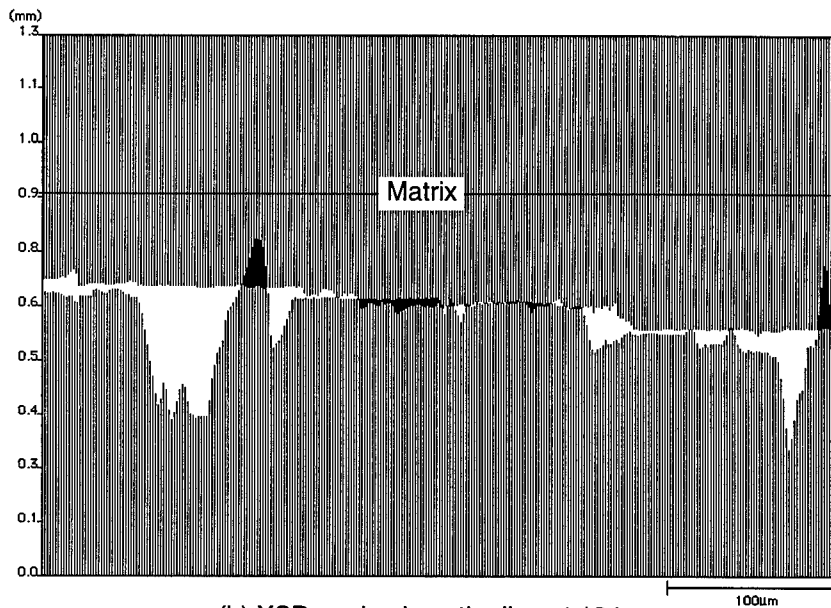
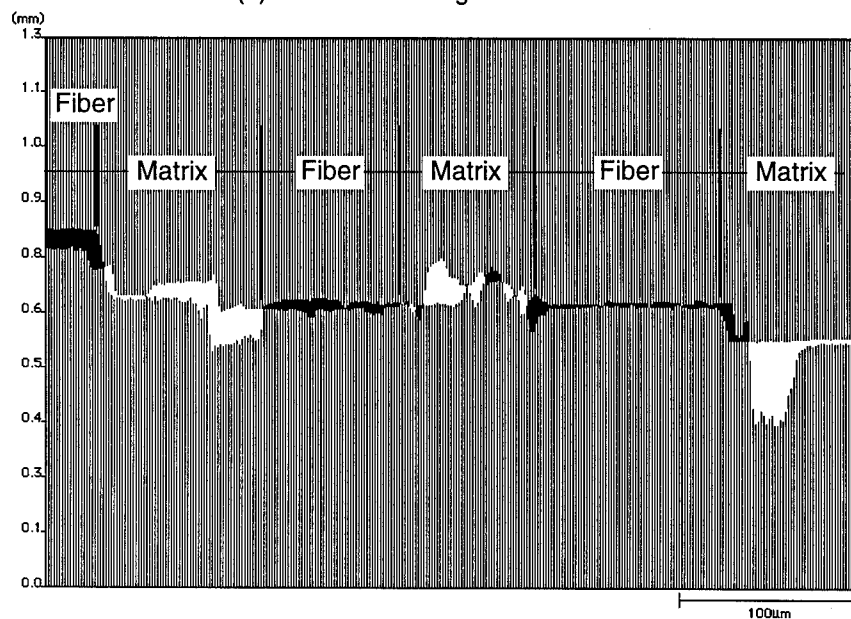
Figure A.8. Cross-sectional plots made parallel to horizontal direction.

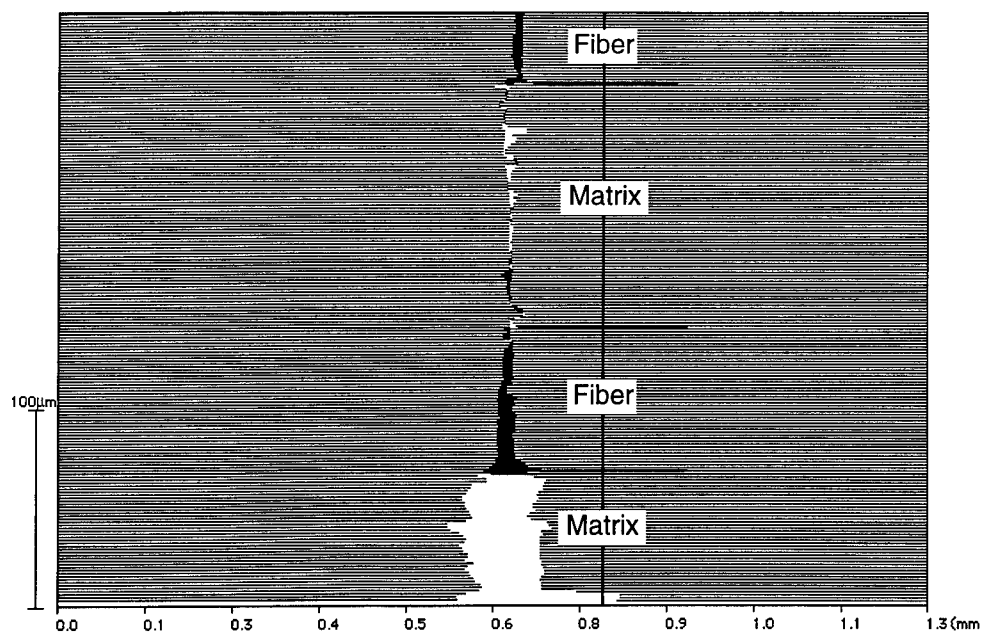
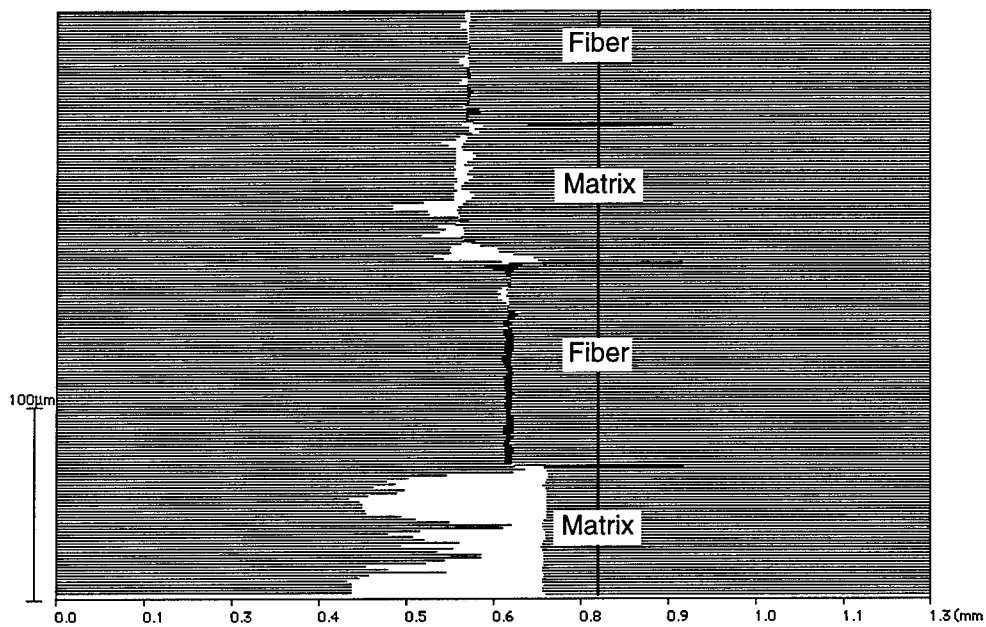
Figure A.9. Cross-sectional plots made parallel to vertical direction.

Areas where large gaps exist indicate that material was liberated from the fracture surfaces, probably by fragmentation of the matrix material.
